Monitoring Data Record

Project Title: U-2524AC Site 1 COE Action ID: 200321137

Stream Name: UT No. 9 to Bull Run DWQ Number: 030909

City, County and other Location Information: Greensboro Western Loop, Guilford Co.

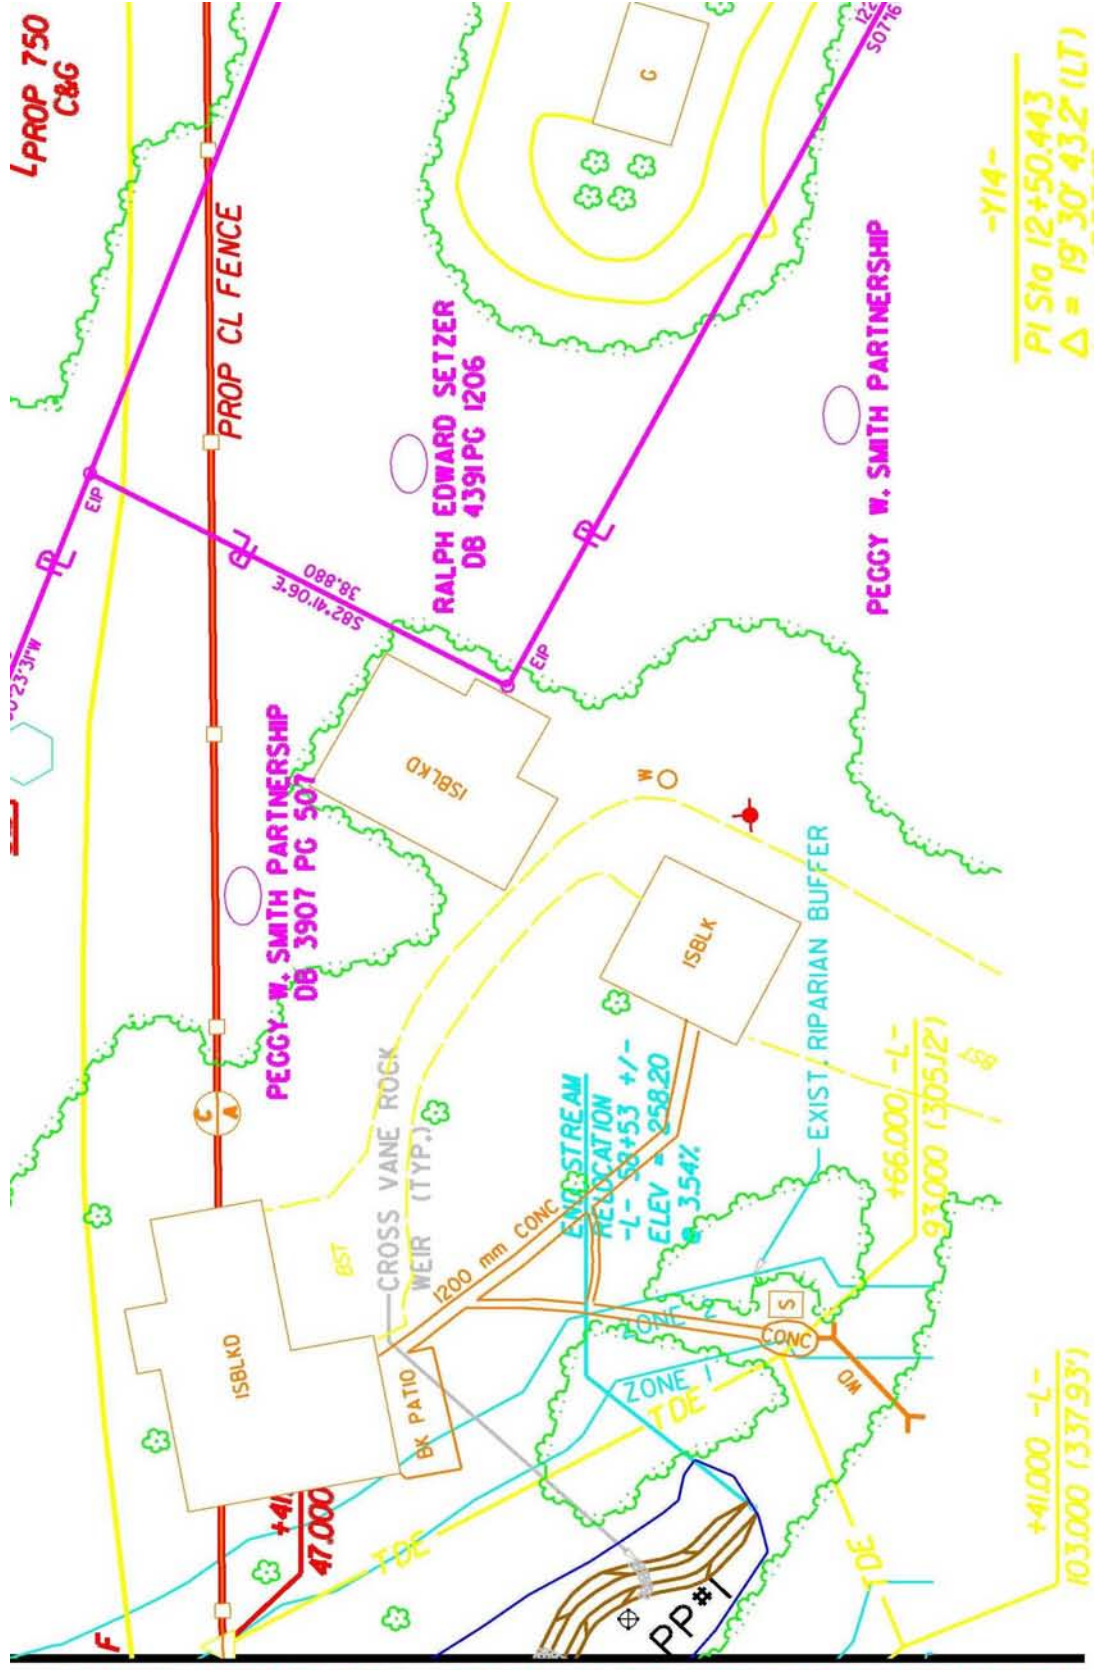
Photo Point #3 (Downstream)

This is the Year 4 Winter evaluation of this stream relocation. The stream is stabilized at this time, except for some minor bank erosion that still exist below a crossvane (Photo Point #3 Downstream). It was also noted during this monitoring evaluation that the last rock on the left arm of this crossvane has dropped off into the channel. A bankfull event occurred at this stream relocation in August 2008. NCDOT will continue to monitor this stream relocation.

Year 4 Winter – February 2009
